KickingBird Tennis Center Upgrade

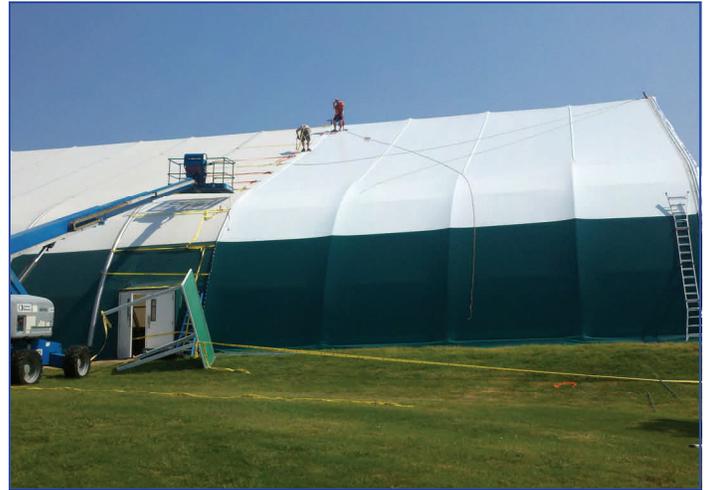
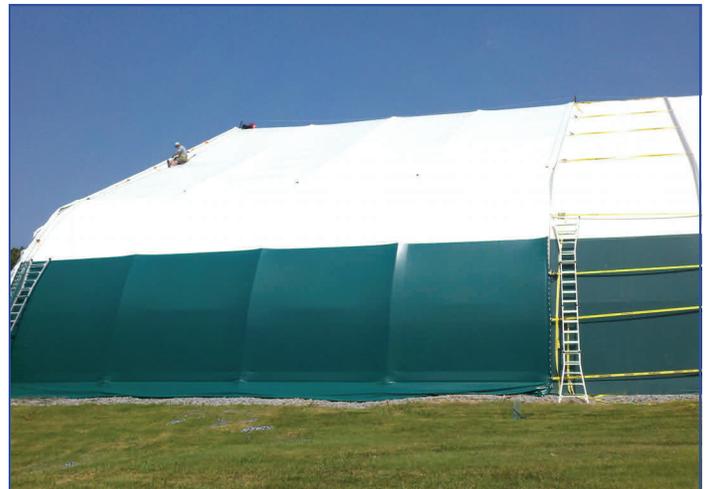
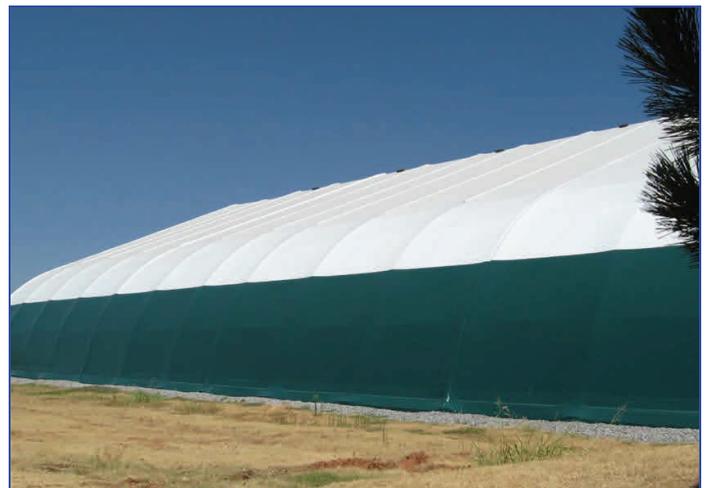
The existing structure spans 118x181' covering a 4 court tennis facility. The building site sits on top of a hill and is exposed to high winds. Years of neglect caused the structure to detension naturally putting undue stress on the membrane and aluminum frame. Consequently, there were cracks in the frame that had to be addressed. Signature designed custom brackets to reinforce the frame and prevent new frame damage. This was done with our engineering to ensure structure code compliance in such an extreme weather location.

Once the frame was addressed, a new Ferrari 602 white and green roof sheet was installed. The roof sheet was designed in large panels to eliminate the traditional multiple panel system commonly associated with leaking.
